Avolites Ltd.
Engineering Change Notice

| Title | Borris 2 Keyboard Interrupt modification |
| ECN Number | ECN-0150 |
| Equipment | Azure, Pearl 2000/2004 , Sapphire 2000 |

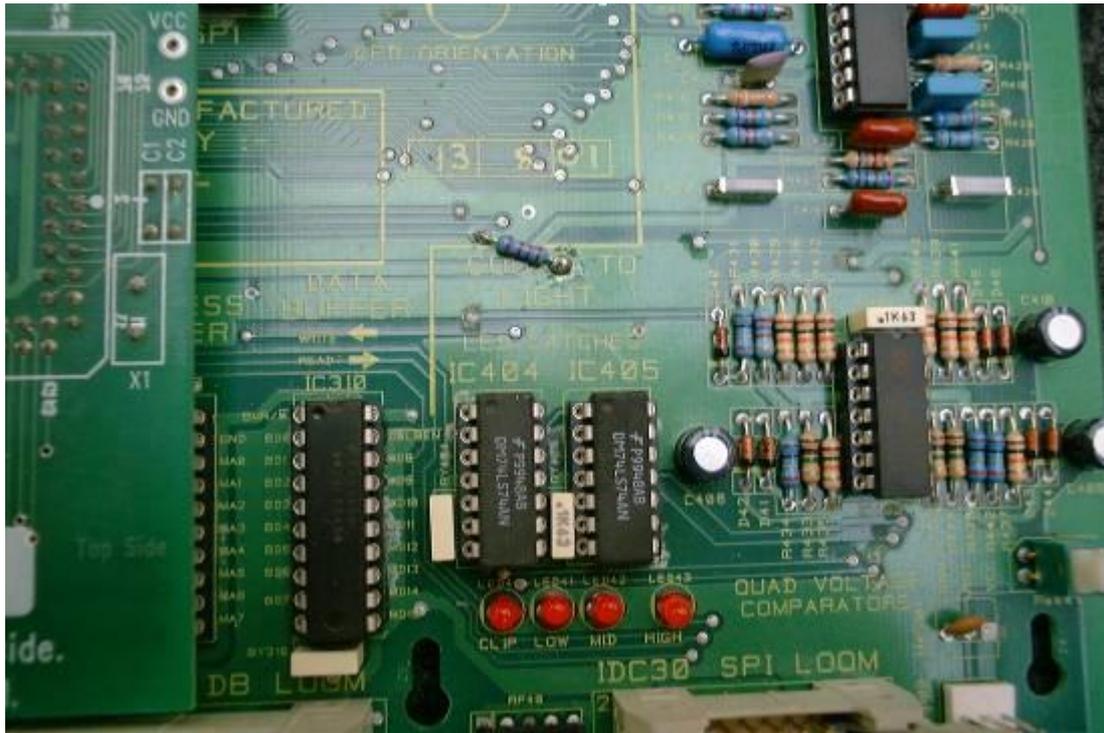
| Reason for ECN | No response to front panel key-presses. (This problem seems to affect a few desks only and is most likely to occur after a 'wipe all',disk operation or power up – ie when desk resets). The problem is caused by noise being picked up by the qwerty keyboard interrupt line and could be temporarily be fixed by plugging a qwerty keyboard. |

| <ol style="list-style-type: none">1. Scrape away small amount of solder –resist (green) on the +5V track just above the 'H' of 'SOUND TO LIGHT' (see photo).2. Solder a 2K2 resistor between above scrape and via (put resistor leg through this small hole) just above the 'S' of 'SOUND TO LIGHT'. |
