# Avolites Ltd. Engineering Change Notice

<b>Title</b>	Diamond 4 LBA modifications
<b>ECN Number</b>	ECN-0158
<b>Equipment</b>	Diamond 4 Vision and Elite
<b>Author</b>	Adam Proffitt and Robert Henry
<b>Date</b>	31/03/05

<b>Reason for ECN</b>	Occasional noise from screen brightness control potentiometer - can be detected from usb panel packet counter. Problem affects playback faders
<b>Special Parts required</b>	None
<b>Special Tools required</b>	None

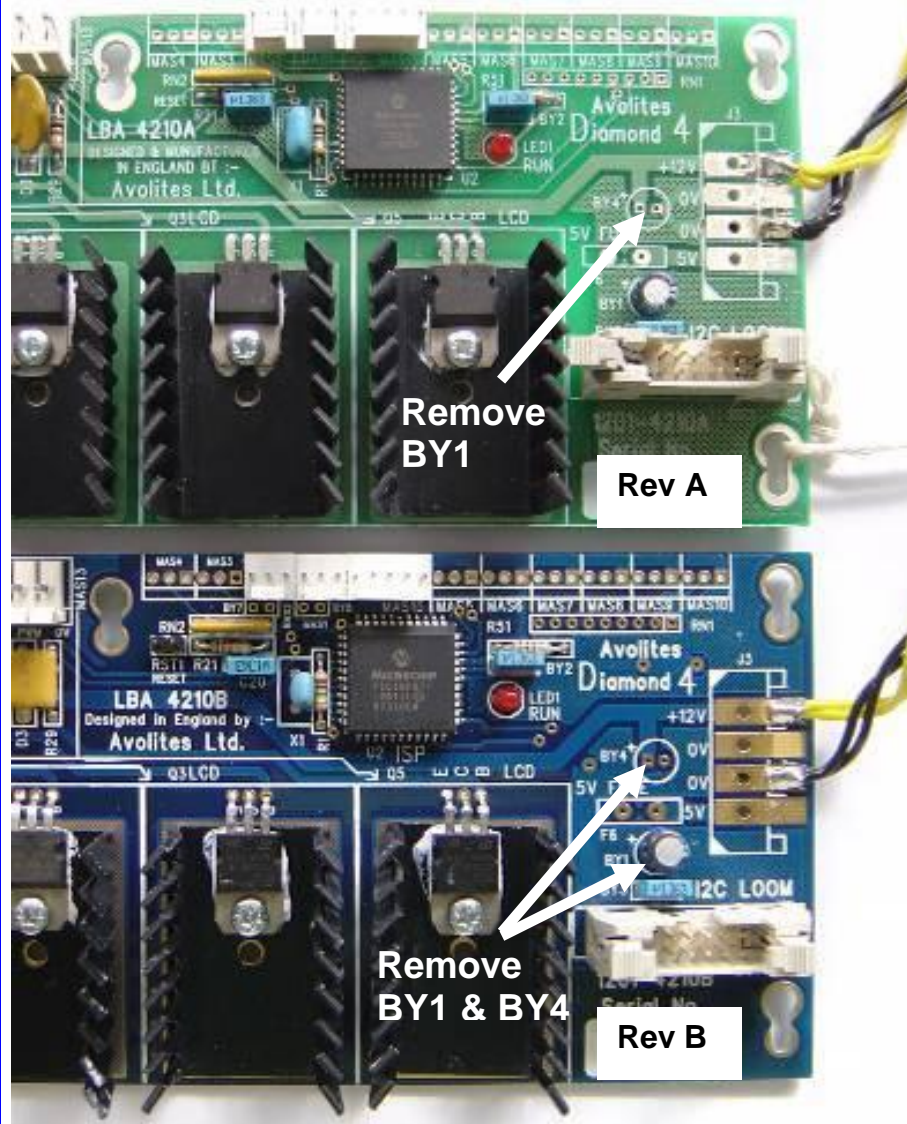
**Note:** These boards already have 2x10nF capacitors fitted between pins 2&3 of MAS1 and MAS2 (as shown in solder side of photo below).

**Note:** Revision B boards Do not require any modifications except for the removal of BY1&4.

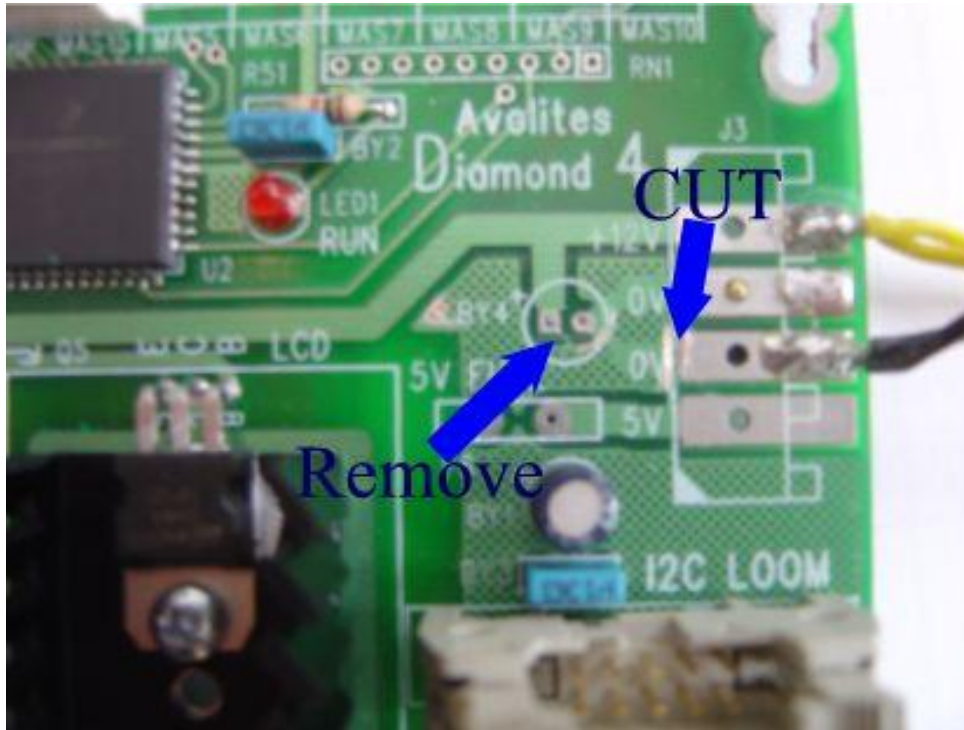
The modifications separate the 0V supply for the dimmed outputs from the 0V supply which is fed from the 10way IDC connector.

1. Cut track near 0V supply cable on component side of board.
2. Remove capacitor BY4.
