Avolites Ltd.

Engineering Change Notice

Title	Pearl Expert Hub USB input connector fixing
ECN Number	ECN-0185
Equipment	Pearl Expert
Author	Adam Proffitt / JB.Toby
Drawing Number	
Date	21/11/08

ENC 185 Fixing the uHub USB looms

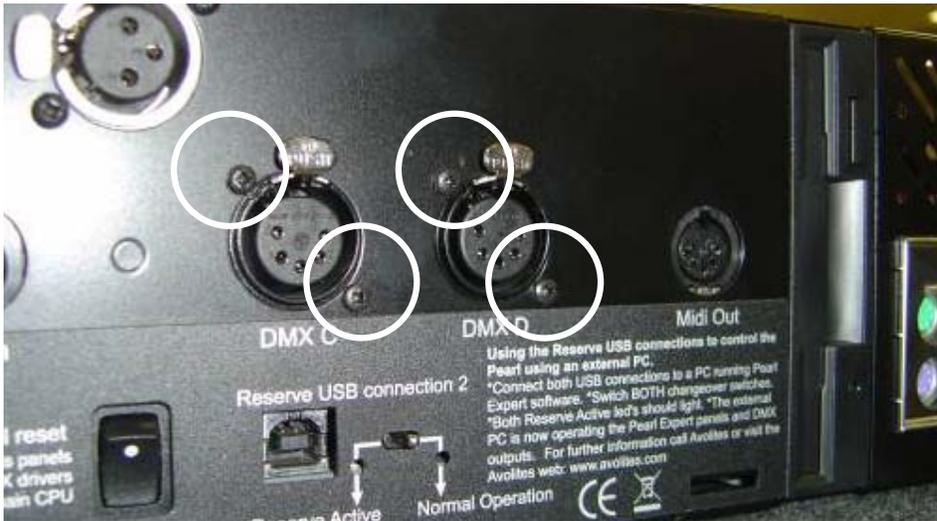
Reason for ECN	Vibrations and shocks may unplug these connections.
Special Parts required	4 off Large cable tie base 4 of Cable tie
Special Tools required	No 2 Pozi drive, small side cutter.

1. Turn the console off and disconnect it from the Mains.
2. Unfasten the four DZUS screws by turning them ¼ turn anti clockwise and open the desk.
3. Remove the 4 self tapping screws from the XLR connectors on each uDMX driver board.

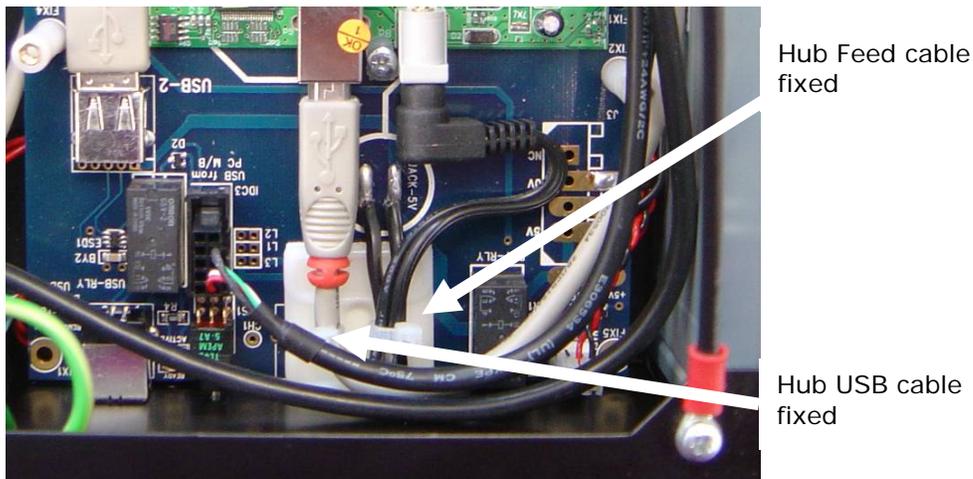
It is important that the USB cable and connector are connected properly and not pulled sideways.

8. Fold the Hub feed cable back and fix it with a cable tie using the right most loop of the cable tie base, see picture below.

9. Reconnect the USB cable to the hub and fix it with a cable tie using the left most loop of the cable tie base. When pulling the cable tie make sure it is pulled back as far as possible to minimize slack.

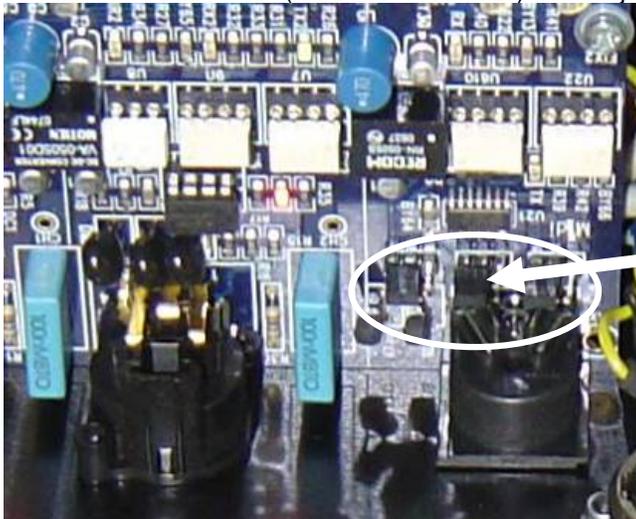
Jumpers in left-most position.

16. Place the DMX boards back into their locations making sure that the boards are in the original position. The boards can be identified by looking at the MIDI jumpers. The left-most DMX PCB (DMX lines A and B) has the jumpers in the left-most position.
