## Avolites LTD Engineering Change Notice

ECN title	Pearl Expert SATA CD Drive Removal

ECN Number	ECN-194		
Related Product(s)	Pearl Experts with serial number 1445-1650		
Date / Author	06/06/2012	CH	
Reasons for ECN	Optical drive SATA connector may reduce SATA reliability		
Parts required			
Tools required	Dzus tool, No2 posidrive screw driver, small side cutter		
Estimated time	15 Minutes

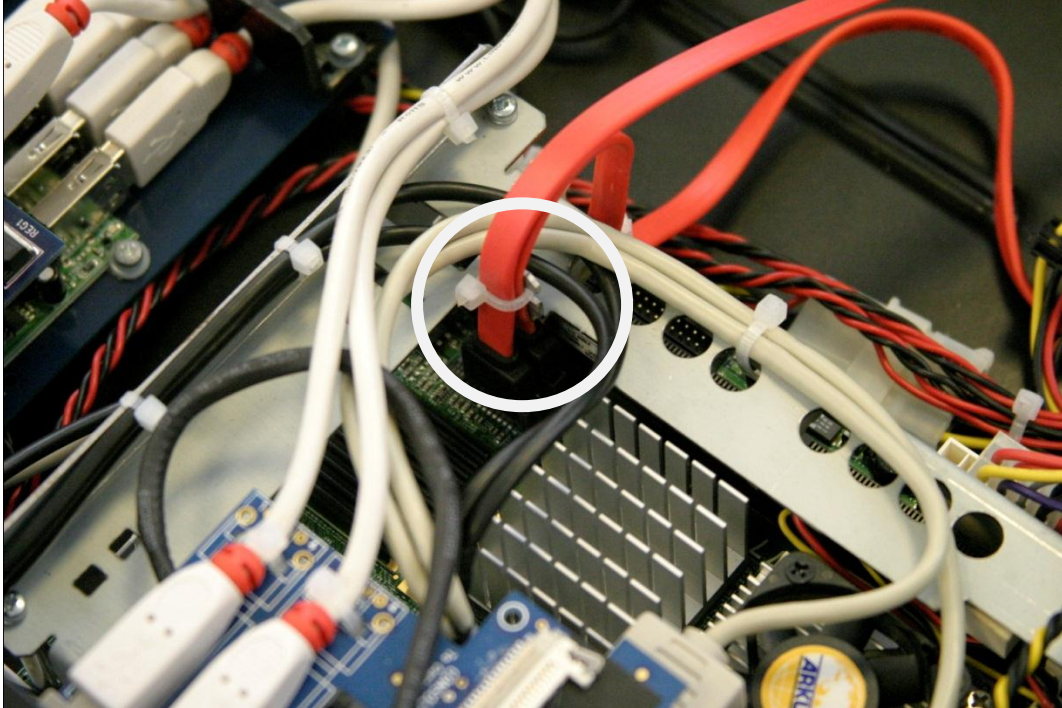
Locate the SATA cables connected to the motherboard (indicated above). Snip the cable tie connecting the two cables together.
