Avolites LTD Engineering Change Notice

ECN title	Quartz Audio Input Timing Capacitor

ECN Number	ECN-200		
Related Product(s)	All Quartz SN QTZ-0010 to QTZ-367		
Date / Author	04/06/2015	JB Toby	
Reasons for ECN	Audio input may not function (no audio seen in Trigger workspace)		
Parts required	None		
Tools required	Pozi drive no 1, small tipped soldering iron		
Estimated time	10 Minutes

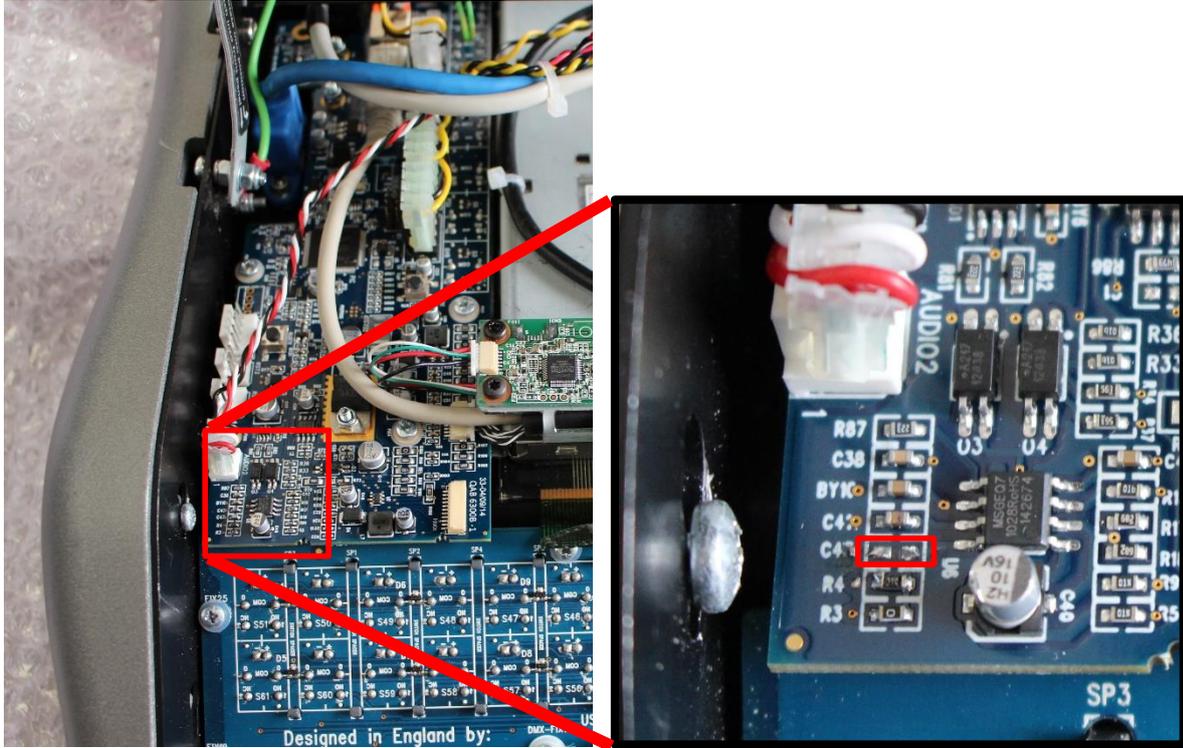
We have become aware of a problem in our supply chain that caused a wrong value component to be fitted to the Quartz Audio Input, this causes the Audio input to not work.

Locate C43 on the QAB board (see picture)

Using a soldering iron remove this capacitor,
