Avolites Ltd. Engineering Change Notice

Title	ART2000 I2C bus pull up
ECN Number	ECN-141
Equipment	All ART2000 control cards build prior to 18-10-2001
Author	J.B.Toby
Drawing Number	
Date	18-10-2001

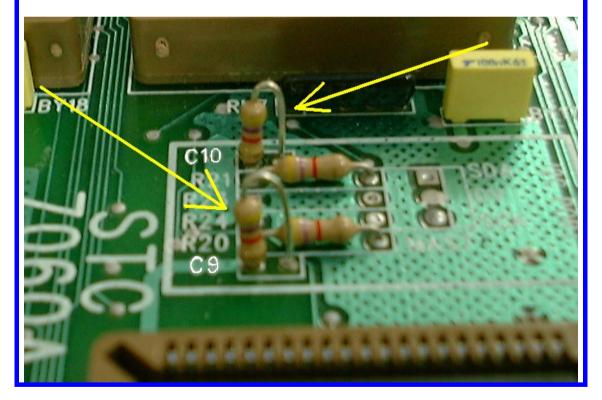
Reason for ECN	Occasional I2C bus corruption during star up and thus bays
	detected
Special Parts required	2x 4K7 0.25W resistors/ solder
Special Tools required	Soldering iron PZ03 screwdriver

- 1. Turn of and power down the ART2000 system
- Unscrew the two Pozi screws holding the control card and remove it
 Fit the two resistors in the C9 and C10 locations (just above the STC 7060A text).
- 4. Replace the control card and test the dimming system.
