Avolites Ltd. Engineering Change Notice

Title ART 4000 main card fixing
ECN Number ECN-0118
Equipment All ART 4000 modules until units with production date later
Than May 2000
Author J.B.Toby
Drawing Number
Date 9th May 2000

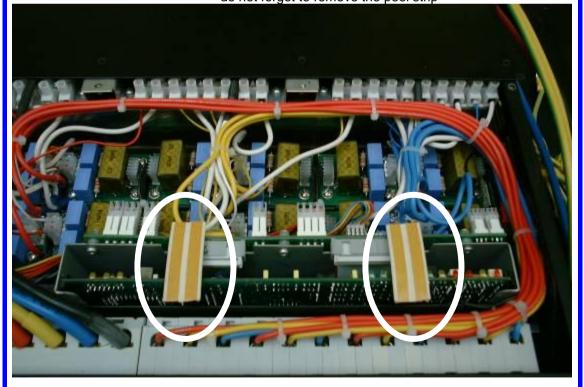
Reason for ECN	The main card can work itself out of the ribbon connectors during transport This may result in poorly starting of the ART 4000
Special Parts required Special Tools required	after being moved. Rubber foam strip set 32-02-9000 (1 set for 1 module) None

Slide the dimmer out of the rack until the slides lock
Remove the front top cover using a size 2 supa drive screwdriver.
place the 2 foam strips on the card as per picture below.
do not forget to remove the peel strip
