Avolites Ltd.
Engineering Change Notice

Title	Pearl Disc Drive
ECN Number:	ECN- 0109
Equipment:	Pearl
Date:	19/05/99
Author:	Adam Proffitt
Revision:	1.0

Reason for ECN:	In case of disk drive failure
Special Parts Required:	High Density 3.5in floppy disk drive
Special Tools Required:	None

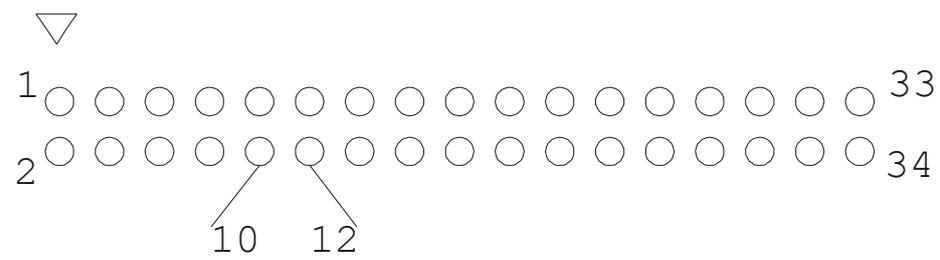
34 WAY IDC

Otherwise linking Pins 10 & 12 on the IDC (34 way) connector inside the drive will have the same effect. Note the pin layout of the 34 way connector - shown below.

Pin number 1 or 2 is usually marked on the circuit board of the disk drive. The disk drive cable has a coloured stripe going to pin 1. If the cable is accidentally plugged upside - down then the disk drive led is usually permanently on but no harm is done.
