Avolites LTD Engineering Change Notice

ECN title	220R resistor mod for BGE encoders		
ECN Number	ECN-0215		
Related Product(s)	Titan Mobiles with BGE encoders SN from TM-5672		$\Delta V \Delta$
Date / Author	22/09/2022	GK	
Reasons for ECN	BGE encoder counting too fast		
Parts required	8200-0215 Titan Mobile ECN 215		
Tools required	T20 driver and hot glue gun		
Estimated time	10 minutes

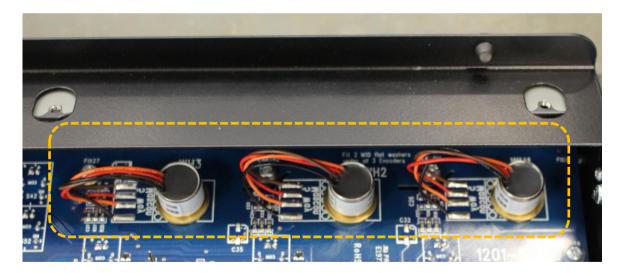
b. The BGE Encoders

We have had a case of new type of Encoders – BGE - are counting too fast. We start using BGE Encoders from SN TM-5672 but there's still a possibility of finding Bourns Encoders in the unit. In the case of BGE Encoders are fitted on MMB board insert the 220R resistor on MMB board – BOOT2 and update the firmware for improving unit usage. In case Bourns Encoders are fitted DO NOT fit the resistor. Details below.

In case BGE Encoders are fitted (photo below) follow the instruction in subsection 2. Modification

Fit the supplied 220R resistor onto **BOOT2** header on MMB board then secure it with hot glue (arrow)
