Avolites LTD Engineering Change Notice

ECN title	DP2DVI supply from QVB

ECN Number	ECN-0218		
Related Product(s)	QTZ with EEPD mobo; SN 03776-04152		
Date / Author	21/04/2023	GK	
Reasons for ECN	LEDs sometimes dim, losing license message on the screen		
Parts required	1221-2148REVA Qtz DP-DVI from QVB supply loom, 3x cable-ties		
Tools required	PZ2 driver, side cutters		
Estimated time	10 minutes

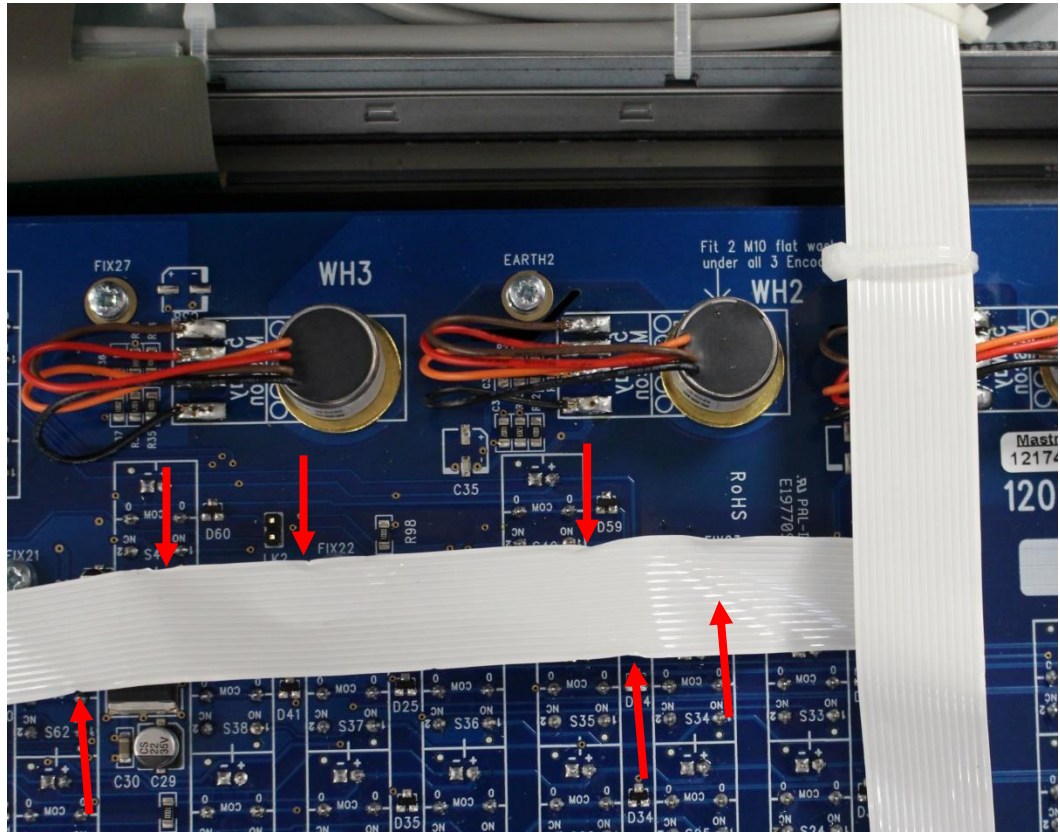
2. FFC looms securing.

Reason for ECN: The FFC looms are getting damaged when the console is closing. FFC looms lose the predicted shape then they get trapped between the Front Panel and the Shell.
