How to fix: [Dongle Not Found](#) on Titan Mobile and TitanOne after a software upgrade.

If **Dongle Not Found** appears after updating to v7.5 the panel firmware requires updating.

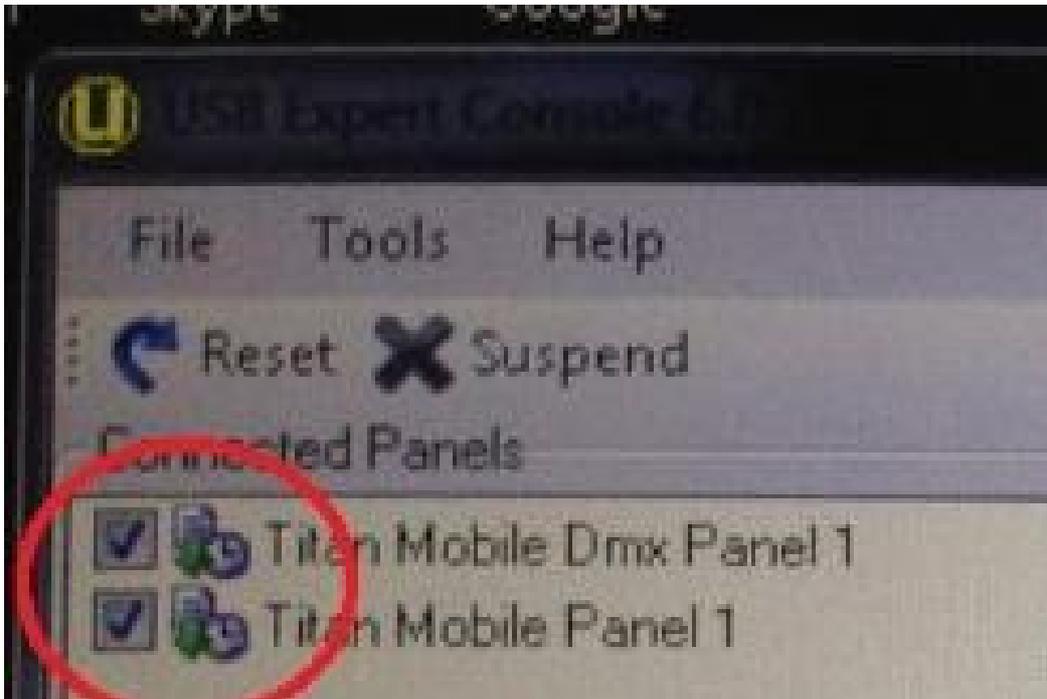
- 2 You will notice that the panels appear with a clock symbol: this indicates that the panels need updating.
