Avolites LTD Engineering Change Notice

ECN title	Sapphire Touch Impedance Matched Ethernet

ECN Number	ECN-206		
Related Product(s)	All Sapphire consoles before SN 300		
Date / Author	27/06/2016	Toby Roworth	
Reasons for ECN	Ethernet link quality can degrade due to poor signal integrity		
Parts required	Assembled TNS etherCon snapoff board		
Tools required	PZ2 screwdriver, PZ1 screwdriver, 5.5 mm socket/nut driver		
Estimated time	15 Minutes

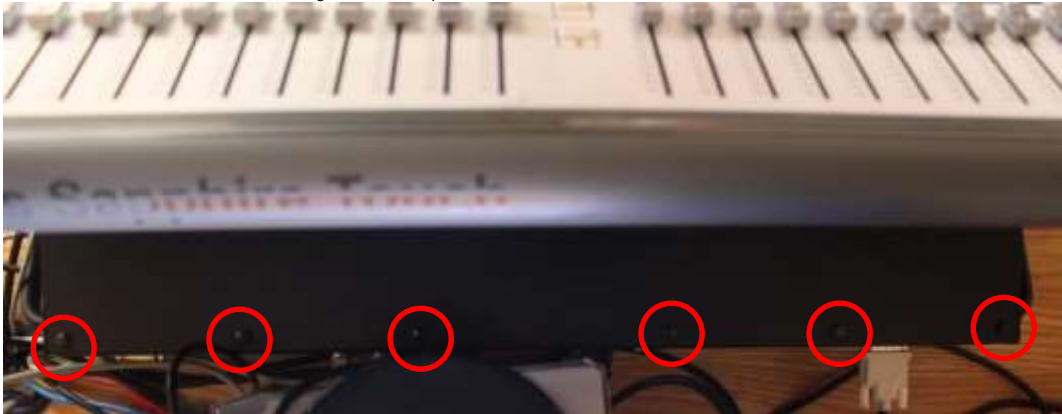
1. Remove the 6 screws securing the back panel.

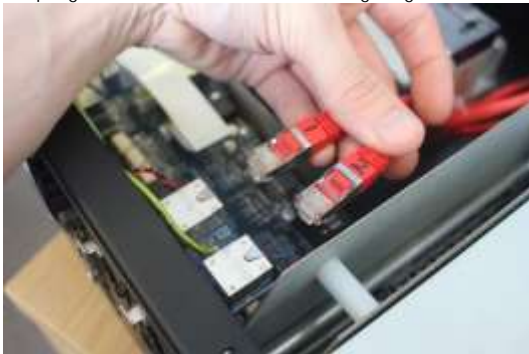
2. Remove the back panel lid.
3. Unplug the two RJ45 connectors going into the Ethernet board.

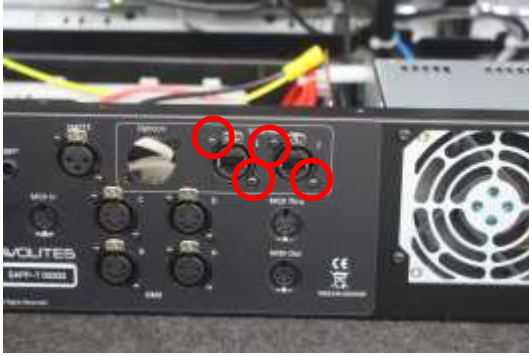
4. Remove the 4 screws holding ethernet sockets 1 and 2.

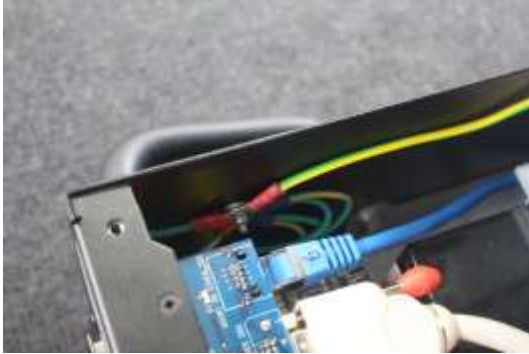
5. Remove the M3 nut holding the earth wires in place, next to the DMX boards. This may be easier if the nearby RJ45 and DVI cables are temporarily removed.

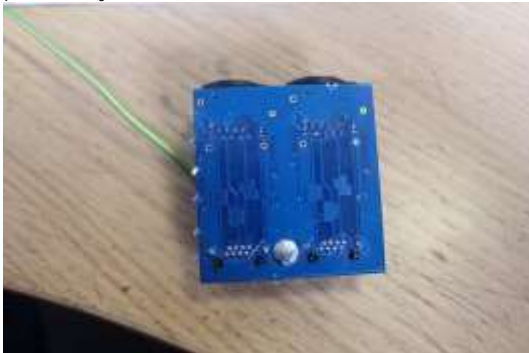
6. Withdraw the ethernet board.
7. Fit the new etherCon board (identified by the wiggly tracks on its underside) using the 4 screws previously removed.

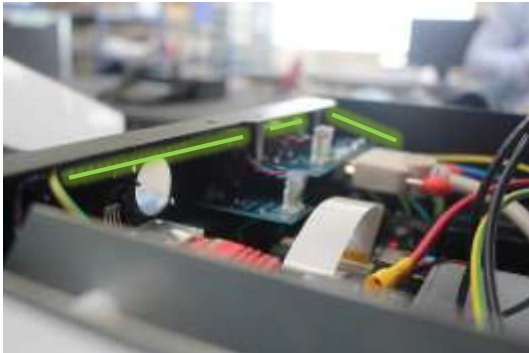
8. Run the earth wire behind the two hex pillars, put the crimp over the earth stud and refit the M3 nut, ensuring all four earth wires are in place, and in contact with one another. (Note that consoles fitted with a DC-UPS will have a fifth earth wire on the stud, which also needs refitting).
