## Avolites LTD Engineering Change Notice

ECN title	Sapphire motor fader belt repair

ECN Number	ECN-0211		
Related Product(s)	All Sapphire Touch console up to ST-0274 All Sapphire fader wings up to STFW-020		
Date / Author	09/05/2015	JB Toby	
Reasons for ECN	Weak clamping of the belt allows for the belt to slip and damage to the belt		
Parts required	RTV Silicone Adhesives, see below for specification Small cable tie to apply adhesive		
Tools required	Tools to remove fader PCB.		
Estimated time	15 Minutes per board once removed from the console A whole console takes up to 3 hours excluding curing time. (PCB remove, inspect and modify faders, PCB replace, test console.

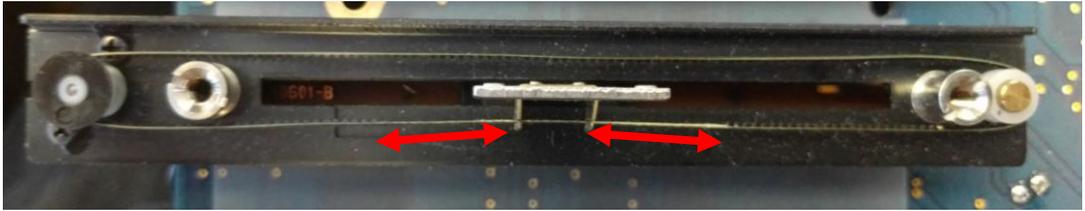
5. Now that all faders have past the initial test, apply the adhesive to all faders as described below;
- A. If the belt has been stripped, place the fader shaft in the centre of the stripped area as shown below

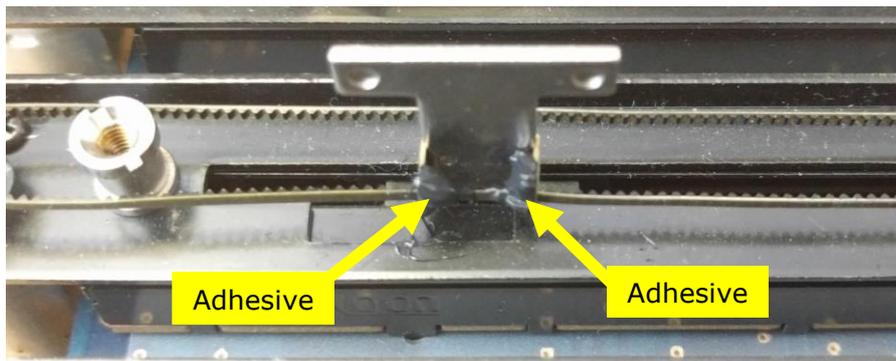
- B. Apply two small dabs (see below for sample size) of adhesive on the **inside** of the fader shaft clamp, make sure to work the adhesive onto the belt as well as the clamp.

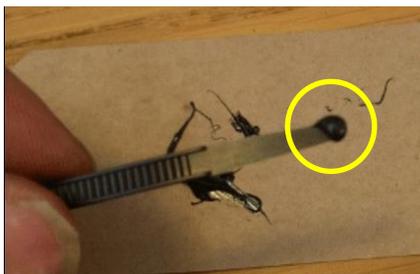
Sample size of amount of adhesive, circa 3mm sphere.
