Avolites LTD Engineering Change Notice.

ECN title	Quartz – Ferrite protection

ECN Number	ECN-210		
Related Product(s)	All Quartz consoles before SN 1701		
Date / Author	23/11/2017	Greg K	
Reasons for ECN	Occasionally the mains wires ferrite stuck in the fan		
Parts required	Cable-tie		
Tools required	Side cutters and No.2 Pozi or T20 Torx drive		
Estimated time	5 Minutes

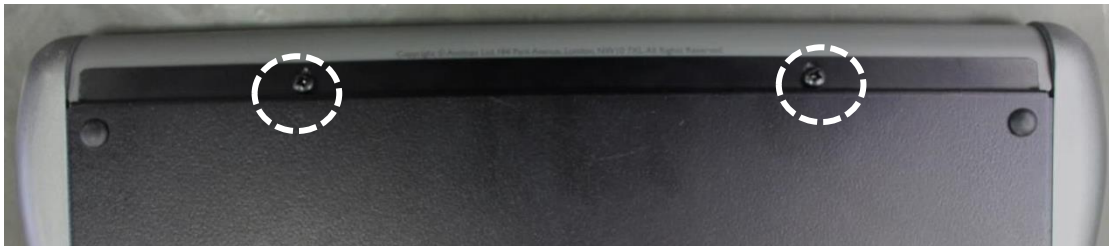
1. Open the console by removing the two screws at the front edge of the console, these screws may be No.2 Pozi or T20 Torx drive

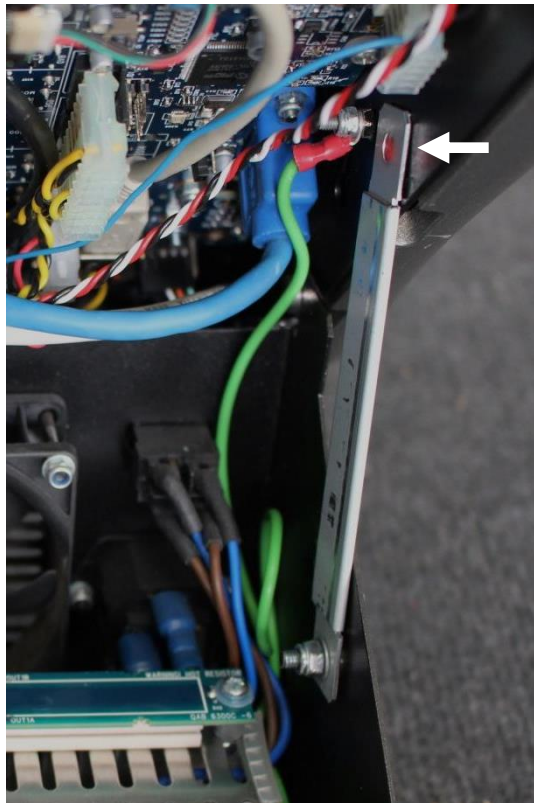
2. Lift the front and hook the stand on the right side of the console to the moulding fixing.

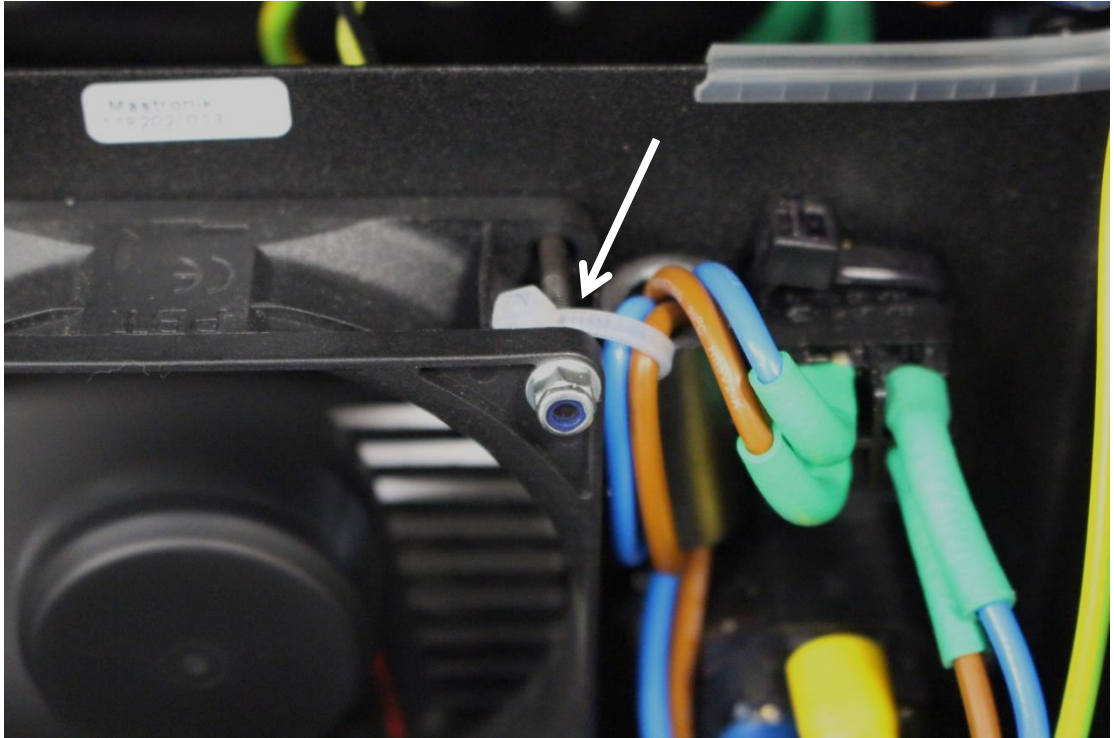
3. Cable-tie two mains wires (the ones going around the ferrite) to the fan screw as shown on picture below
