## Avolites LTD Engineering Change Notice

ECN title	Pearl Expert SATA CD Drive Removal

ECN Number	ECN-194		
Related Product(s)	Pearl Experts with serial number 1445-1650		
Date / Author	06/06/2012	CH	
Reasons for ECN	Optical drive SATA connector may reduce SATA reliability		
Parts required			
Tools required	Dzus tool, No2 posidrive screw driver, small side cutter		
Estimated time	15 Minutes

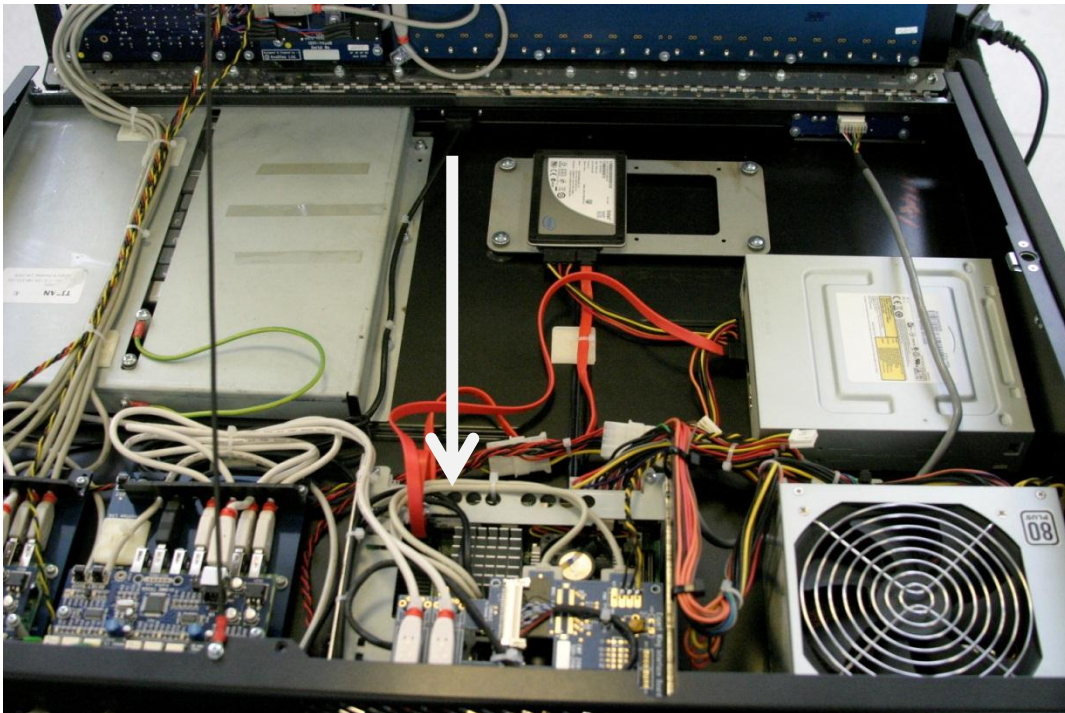
Locate the motherboard (at the rear of the console, indicated by the arrow above).

Unlock the console by turning the Dzus screws one quarter-turn anti-clockwise.

Open the console by lifting the front panel fully from the rear of the unit.
