Avolites Ltd.

Engineering Change Notice

| Title | Borris 2 Xtal |
| ECN Number | ECN-0115 |

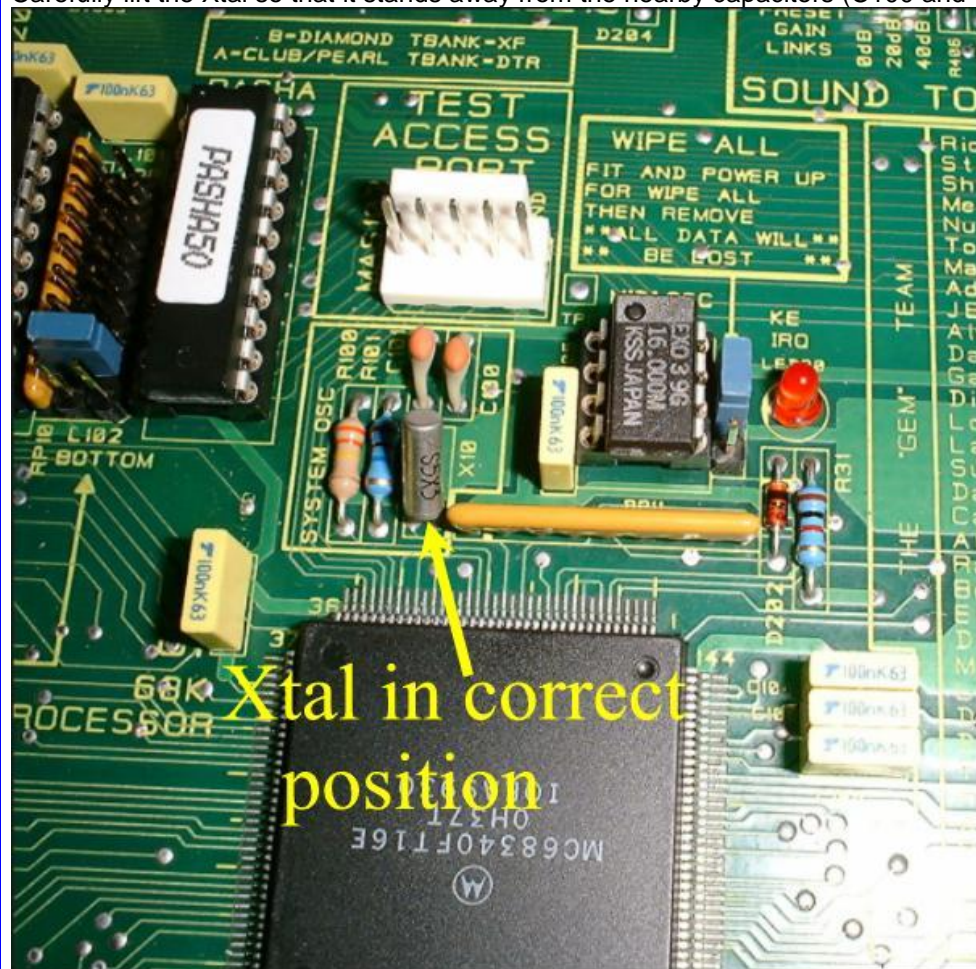
| Reason for ECN | CPU crystal can intermittently touch capacitor legs and cause erratic desk operation. |

Locate cylindrical Xtal (marked X10 on circuit board) next to MC68340 processor on Borris 2 motherboard.
Carefully lift the Xtal so that it stands away from the nearby capacitors (C100 and C101).
